TECHNICAL NOTE

No. 1887

EFFECT OF HIGH SHEAR RATE ON EROSION
OF COMMON BEARING METALS

Lewis Flight Propulsion Laboratory
Cleveland, Ohio

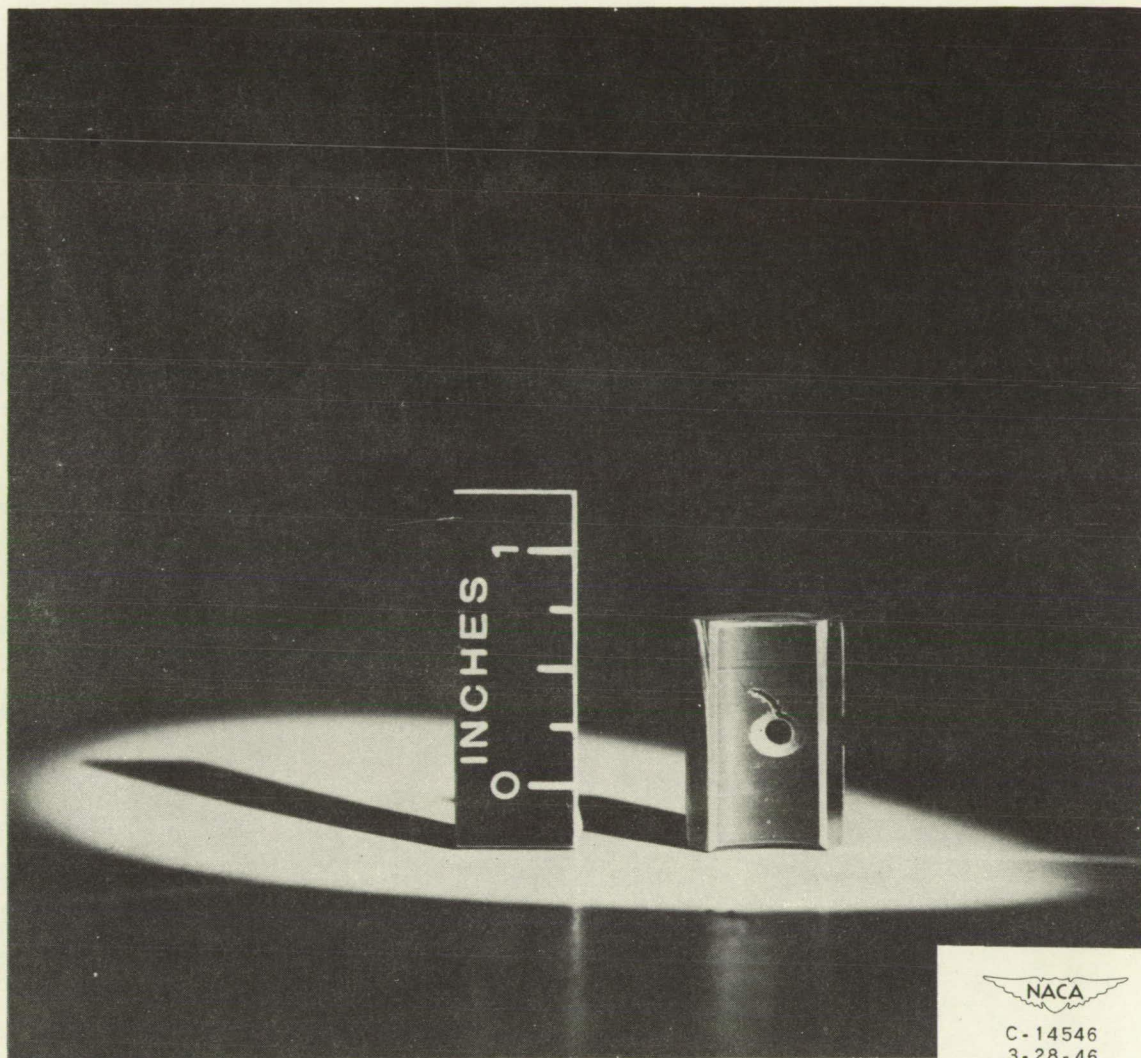
Journal bearings operating under conditions of high surface velocity and dynamic loading have been found to erode or suffer loss of metal in regions surrounding oil inlet holes or grooves. In some instances, the erosion is extensive enough to reduce the effective bearing area and cause the bearing to fail by overloading. An example of severe erosion adjacent to an oil hole in a high-speed bearing is shown in figure 1. In this case, the erosion created a deep, narrow, curved groove extending from the central oil hole.

Figure 1. - Severe erosion adjacent to oil hole of bearing.

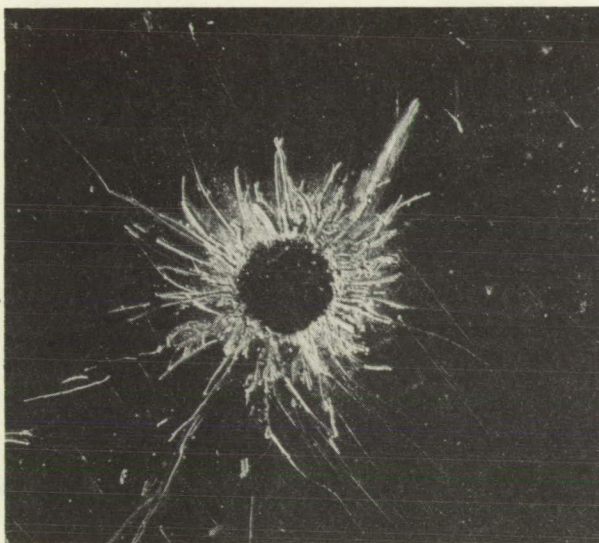
C-23073
3-3-49

The results obtained from the series of experiments in which the unfiltered oil was caused to flow radially outward between parallel surfaces of specimen and nozzle showed that foreign particles produced the pseudoerosion shown in figure 6. These particles were probably wear particles from the high-pressure pump. As might be expected, this damage began to occur soon after the pump was started and occurred regardless of the size or shape of the central oil hole. Figure 7 shows the types of flow nozzle used in the erosion studies. When the oil-film thickness was 0.001 inch and a central oil hole 1/64 inch in diameter was used, the small wear particles were able to pass between the surfaces without interference and the long extended scratches ceased to occur. However, a "sandblast" effect was evident on the specimen in the region opposite the central oil hole, as shown in figure 8. This effect is caused by the small particles striking the specimen surface and abrading it as they flow out of the central hole and change direction to flow out between the nozzle and the specimen. The nature of these occurrences was verified by visual observation with the apparatus of figure 4, the foreign particles appearing as points of light in the oil. Replacing the high-pressure oil filter in the oil system completely eliminated this form of surface damage.

Figure 6. - Pseudoerosion caused by scoring of particles carried in oil. Particles large compared with oil-film thickness; oblique illumination. $\times 10$
